On-Orbit Spacecraft Inspection

Neptec's Laser Camera System (LCS) is used to make high-precision 3D measurements of spacecraft surfaces at ranges of one to three metres.

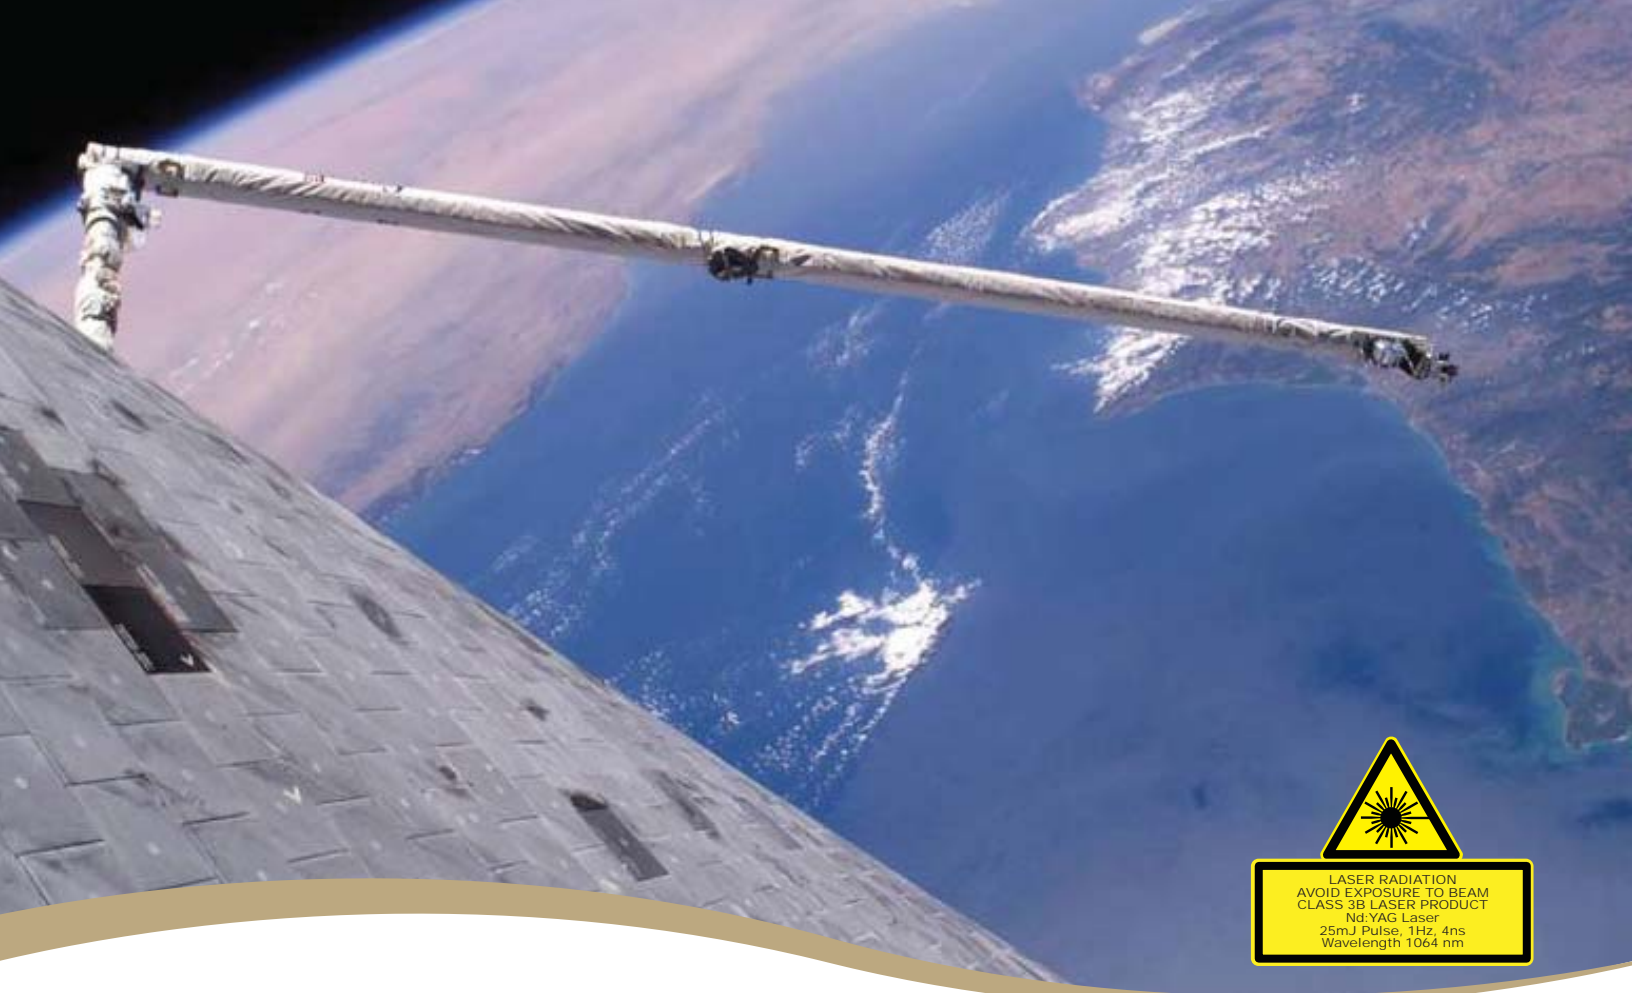
Neptec's LCS is a high-precision autosynchronous triangulation 3D laser scanner designed to perform on-orbit inspection of spacecraft.

The LCS was part of NASA's standard shuttle manifest and was a mandatory system on every shuttle mission. Its role was to scan the shuttle's thermal protection system (TPS) to assess areas of interest, perform high precision damage inspection, and facilitate clearance of the shuttle for landing.

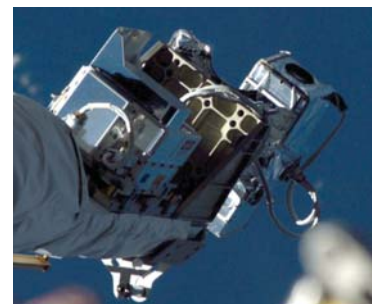
STS-118 sustained damage that had the capacity to pose a threat to the crew and shuttle upon re-entry. The LCS was used to gather 3D data, enabling NASA to duplicate the damage and conduct tests in a simulated environment. This effort concluded that the shuttle was safe for re-entry.

Damage was incurred on STS-122 when part of the thermal blanket lifted. The LCS was used to inspect this area, allowing NASA to determine that the damage did not pose a threat to the shuttle upon re-entry.
